Village of
Yellow Springs

Water and Wastewater Treatment 2020

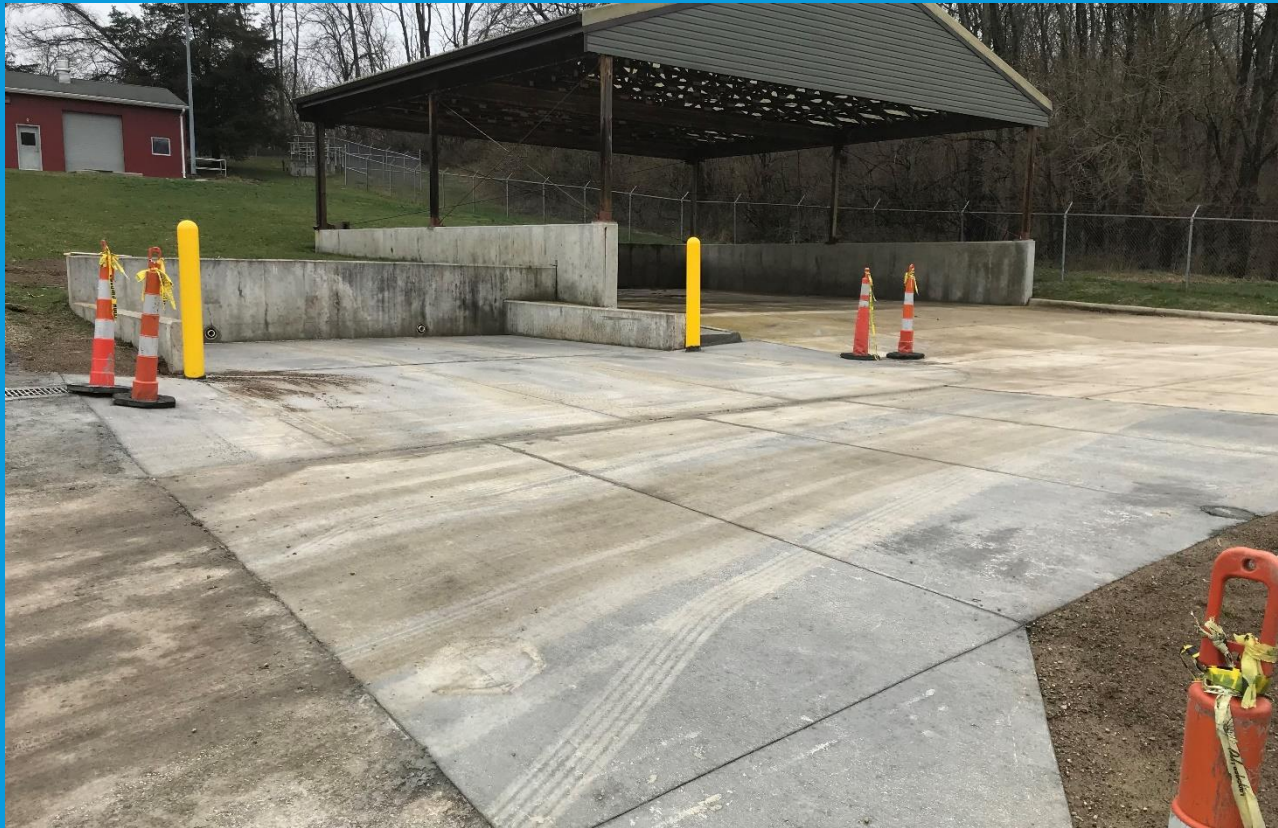
INSTALLED VACTOR DUMPING STATION

- Now have the ability to clean and maintenance sewers on regular basis and be able to dispose of contents.

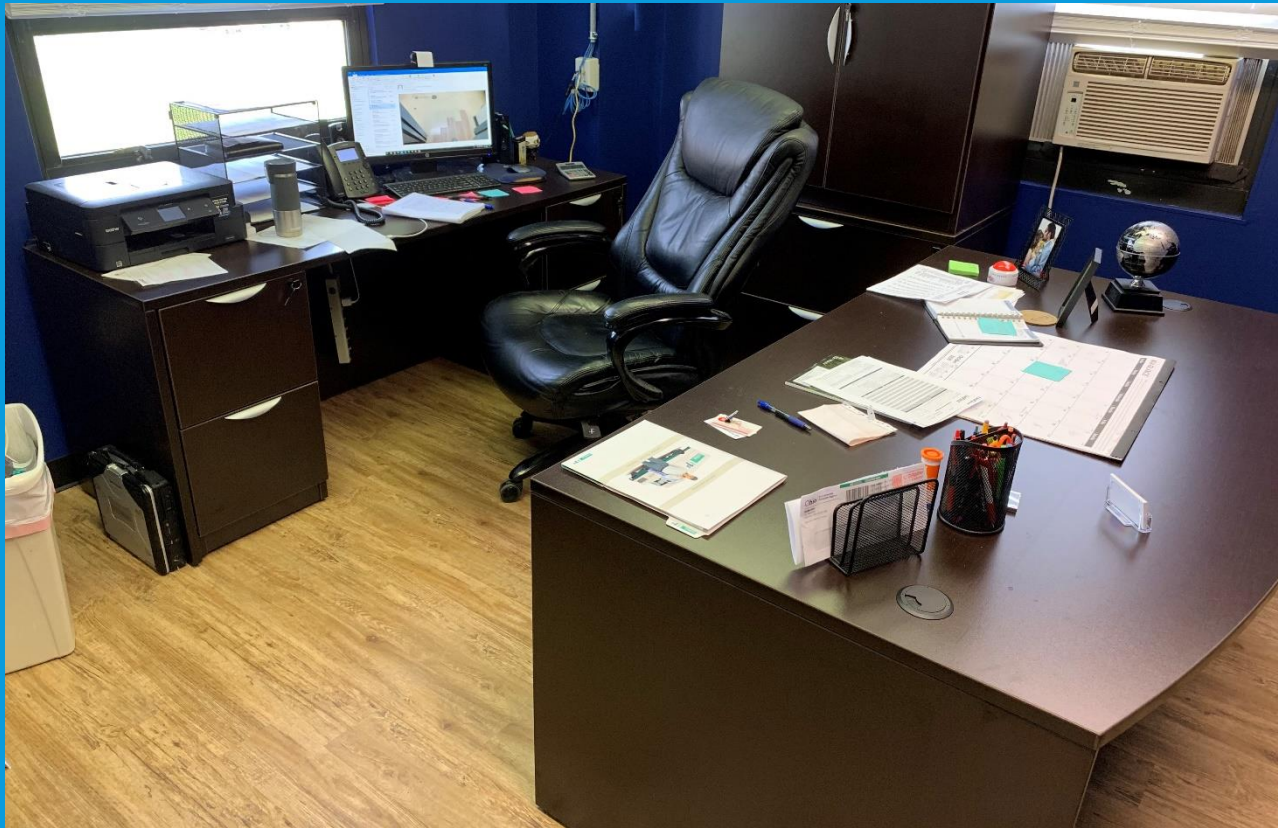
REMODELED ADMINISTRATION BUILDING

- Installed New Flooring
- Painted Superintendent's office
- Painted Operator's office/Lab
- Installed new Office furniture in Superintendent and Operator/Lab office.

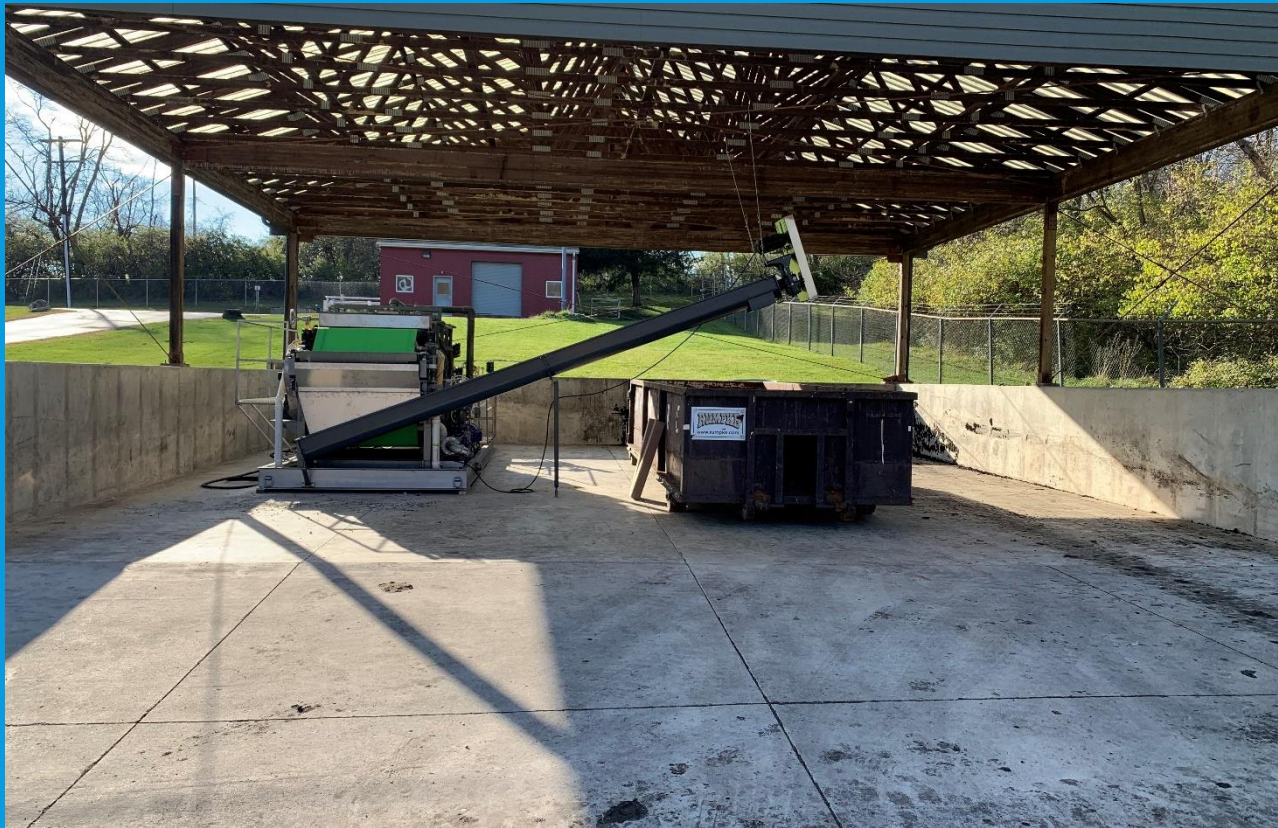
RENTED AND INSTALLED SLUDGE PRESS

- We now have the capability to press and remove our biosolids.
- We can complete this with current staff and not rely on contractors.
- We will be completing a 1 year "test run" to see if this will work well for us.

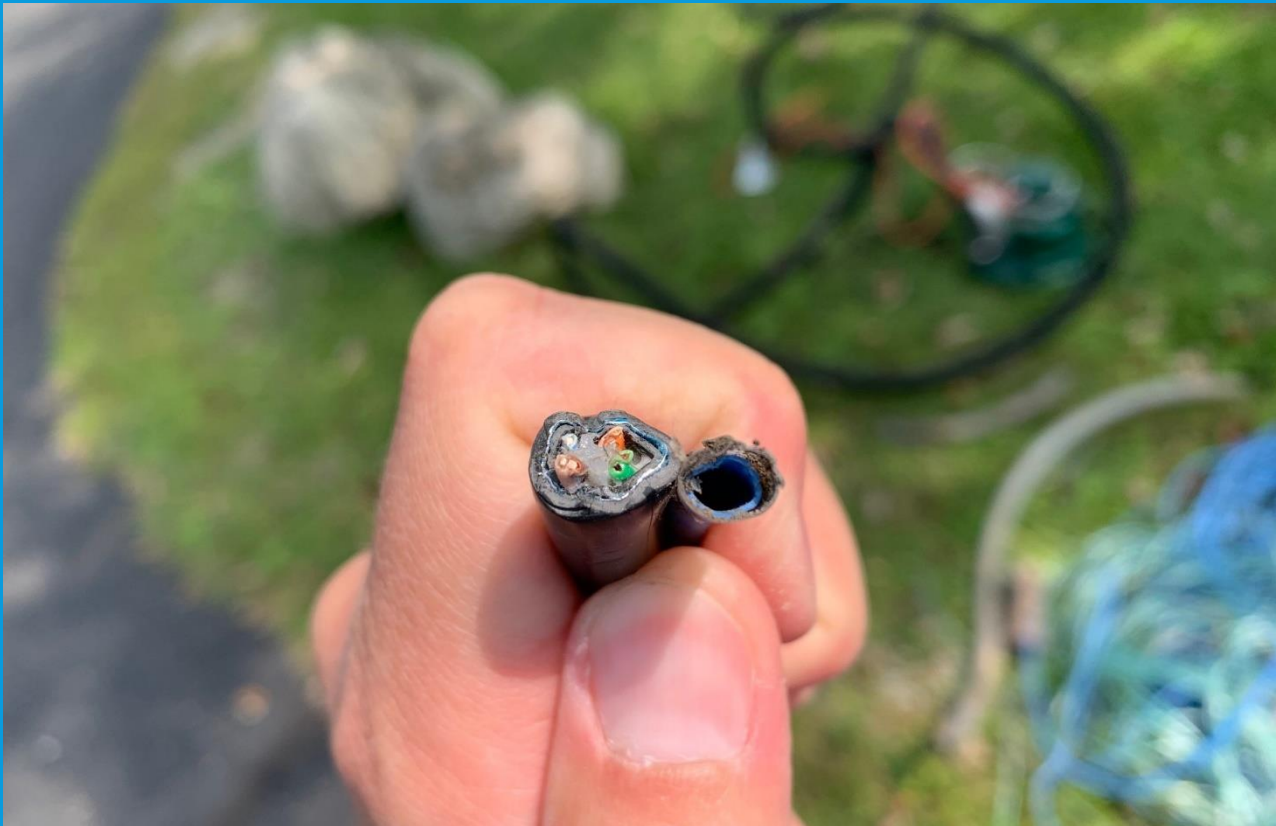
SOLVED INTERMITTENT COMMUNICATION FAULTS

- Replaced Cat 5 cable with new Cat 6 Ethernet cable.
- The old Cat 5 cable was not rated to be exposed to outside elements like it was.
- The new Cat 6 cable is highly insulated and better suited for our operation system.

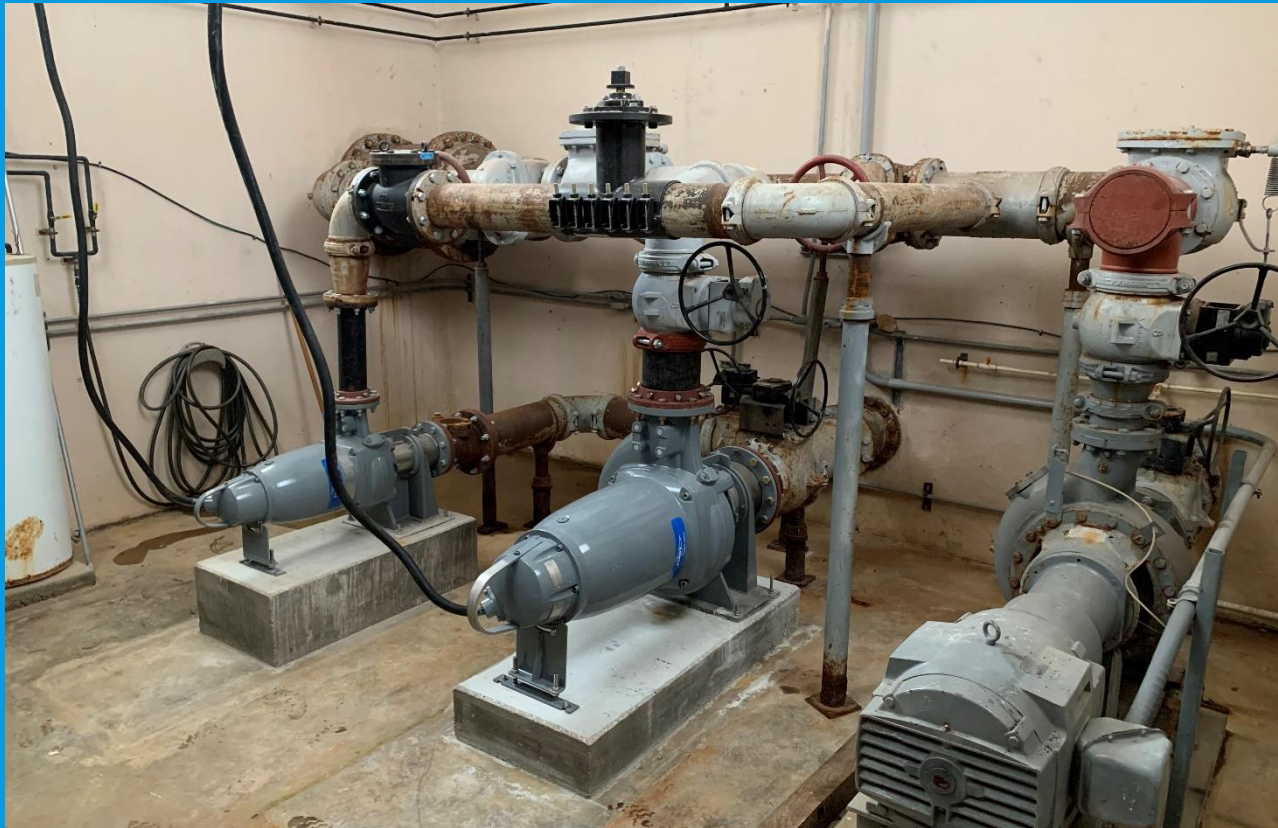
INSTALLED 60HP PUMP

- The new submersible pump replaced an old failing 50HP
- The new pump does not use seal water and will help with high flow events.

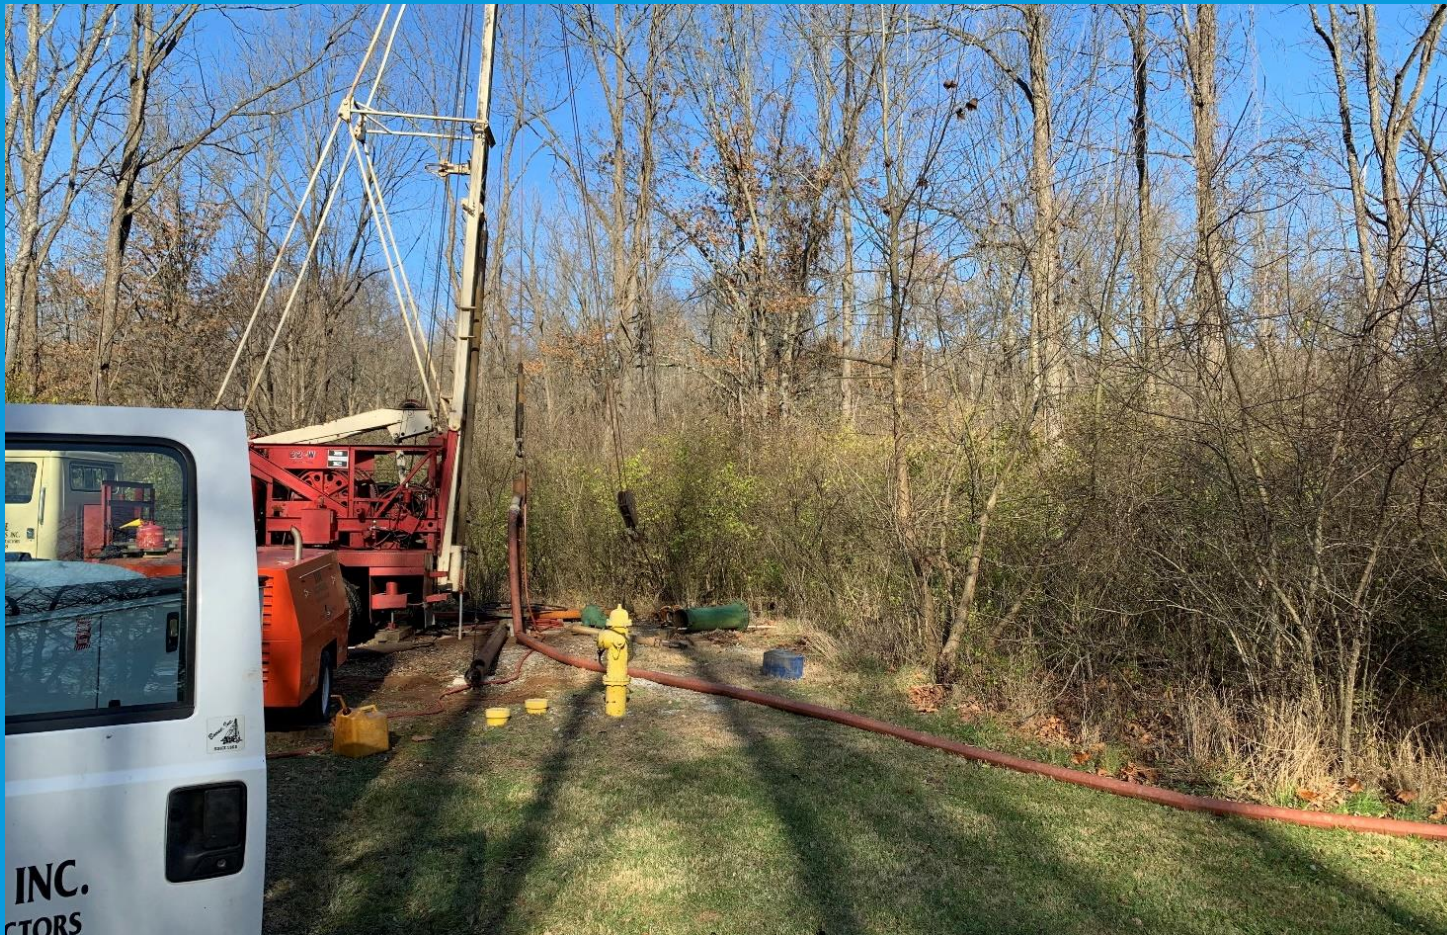
CLEANED WELLS NO.2 & NO. 5

- During the cleaning of Well No. 2 we noticed the well casing has very large holes and needed immediate attention to prevent it from caving in.
- Well No. 5 was extremely dirty but cleaned up and is in good condition.
- We have begun to reline Well No.2 with a 10" pipe. Making it able to use until future plans are made to re-drill the well.

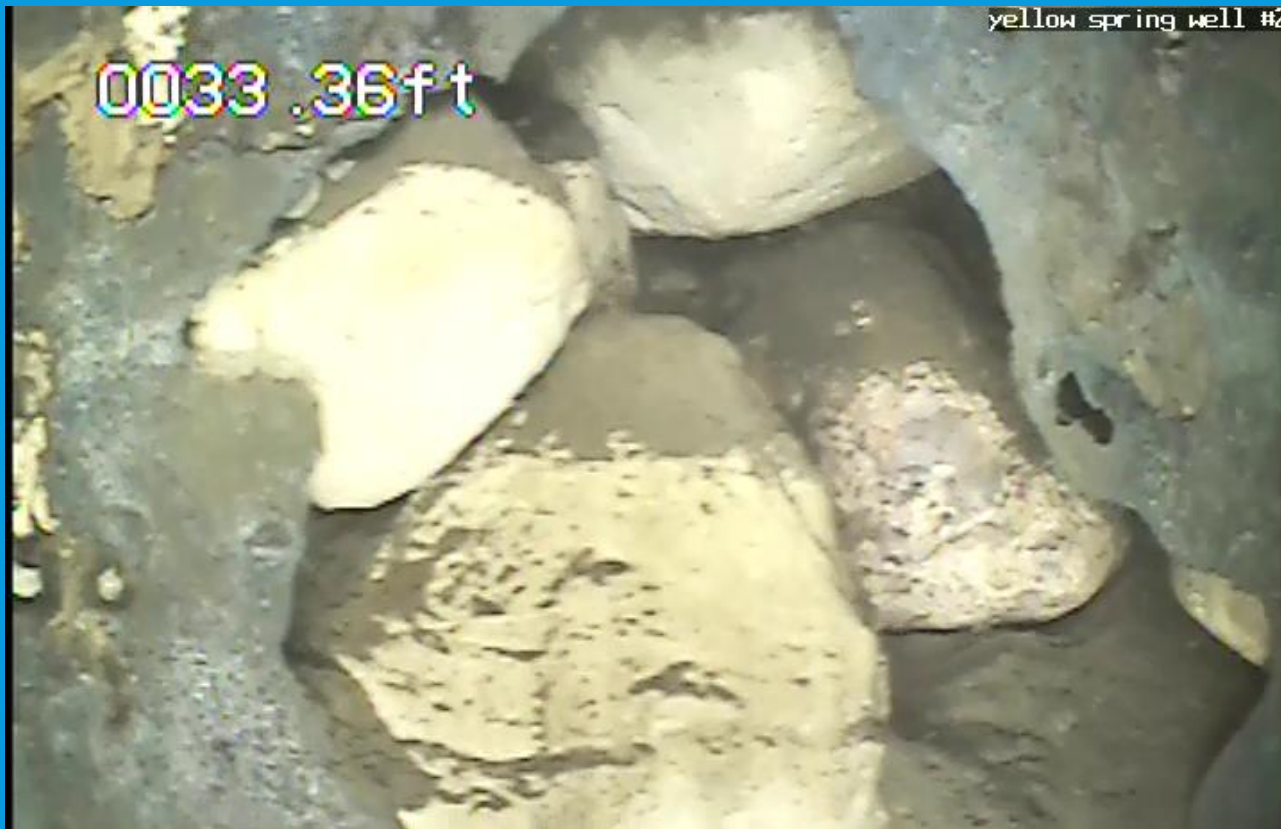
WELL NO. 2

- During the cleaning of Well No. 2 we noticed the well casing has very large holes and needed immediate attention to prevent it from caving in.

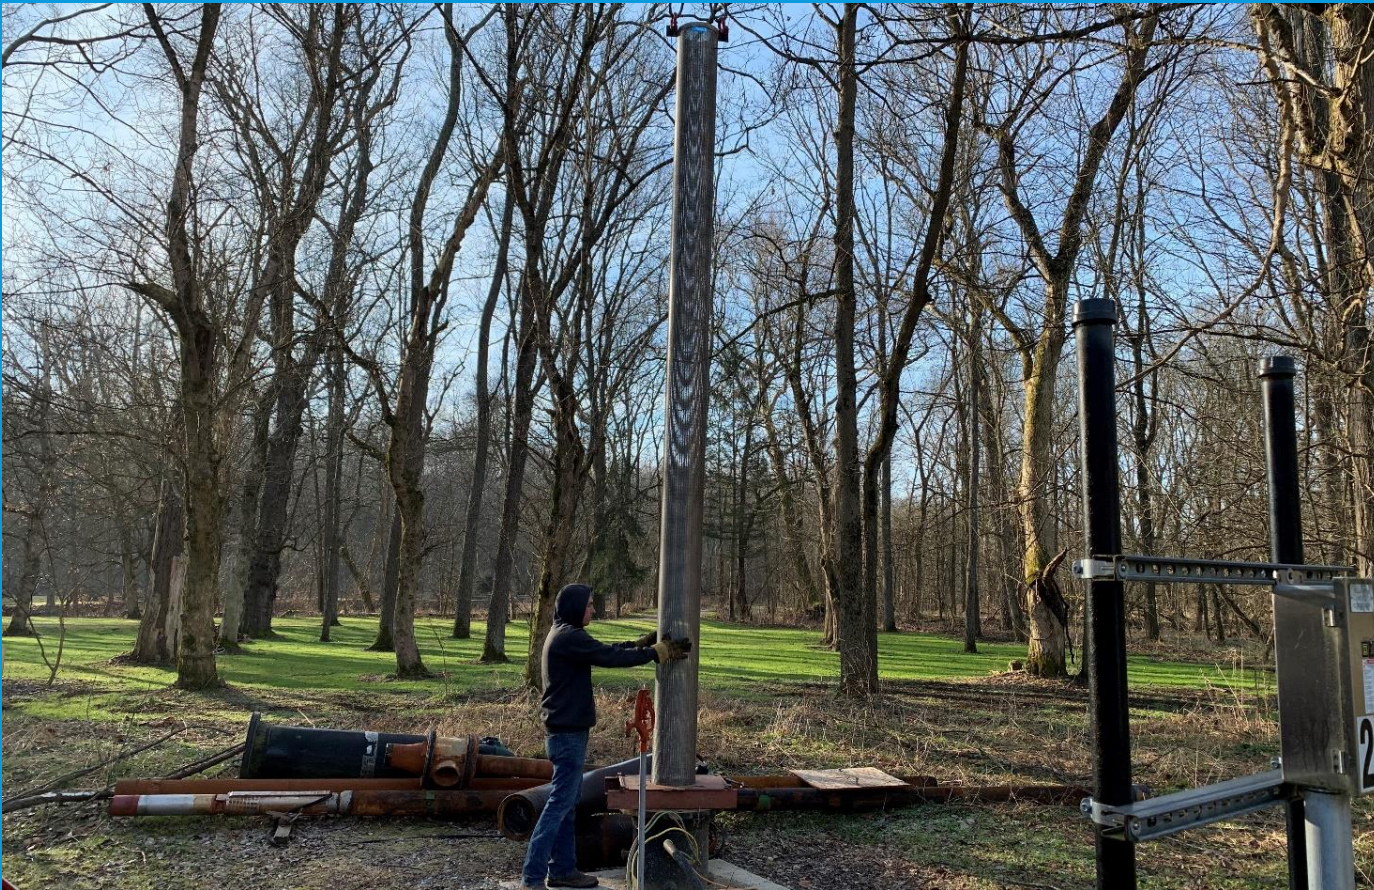
WELL No.2 RE-LINNING

- Installation of 10" screen

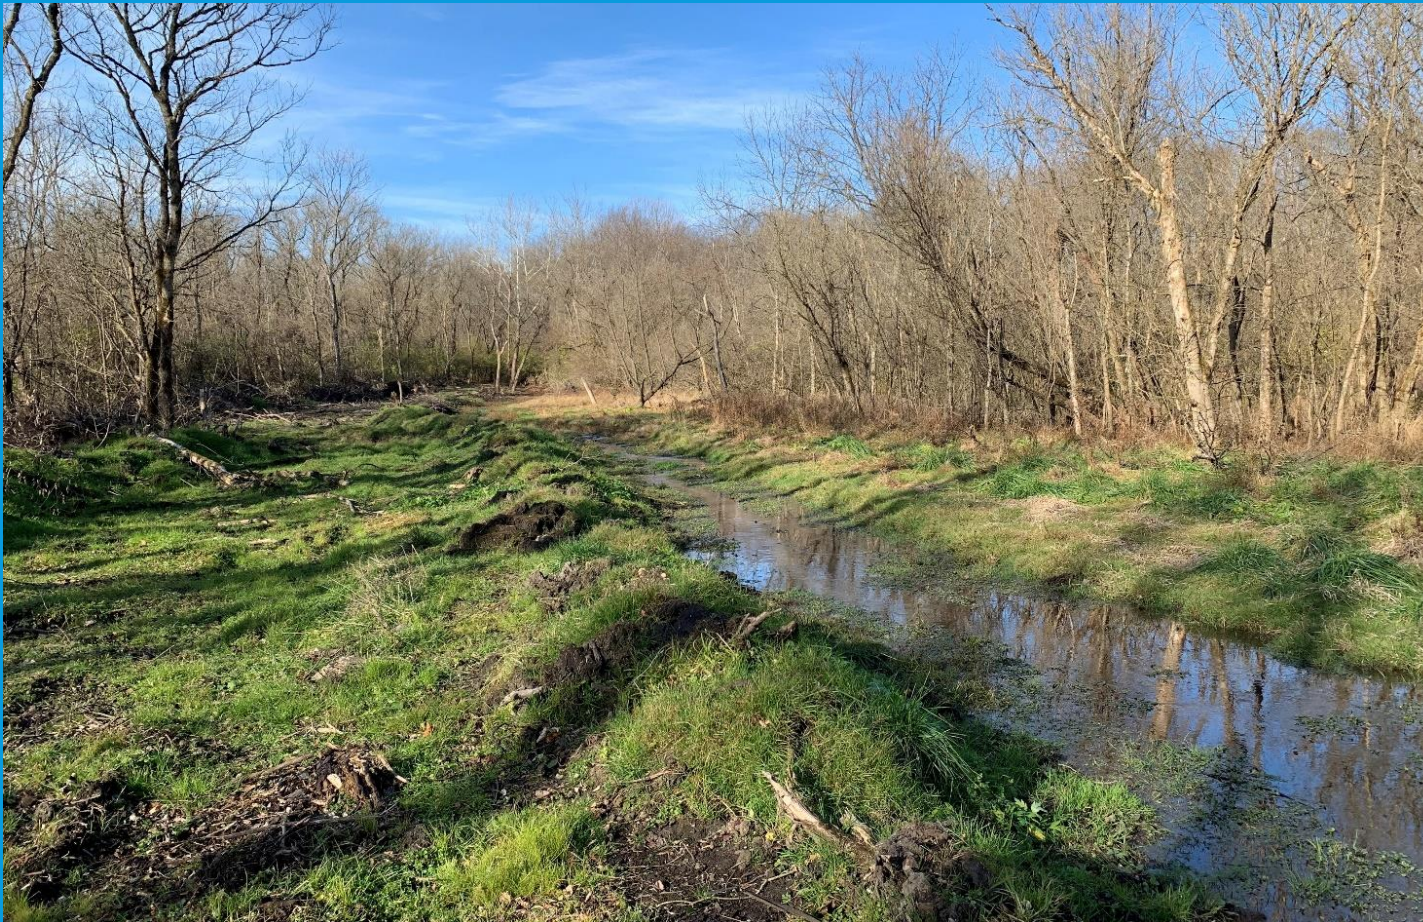
FIXED BACKWASH DRAINAGE ISSUES

- The backwash was draining into the woods and flooding the Well Field.
- Cleared out a gully for backwash to flow to stream.
