WATER RECLAMATION FACILITY The Most **Colorful** Experience in Wastewater

WWTP Improvements Project

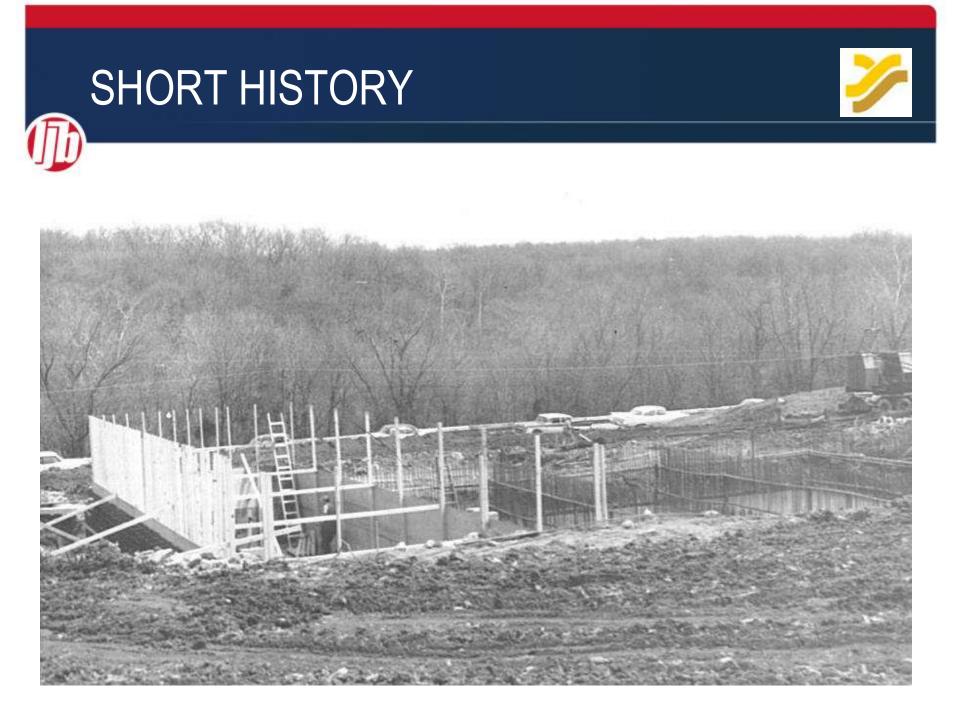
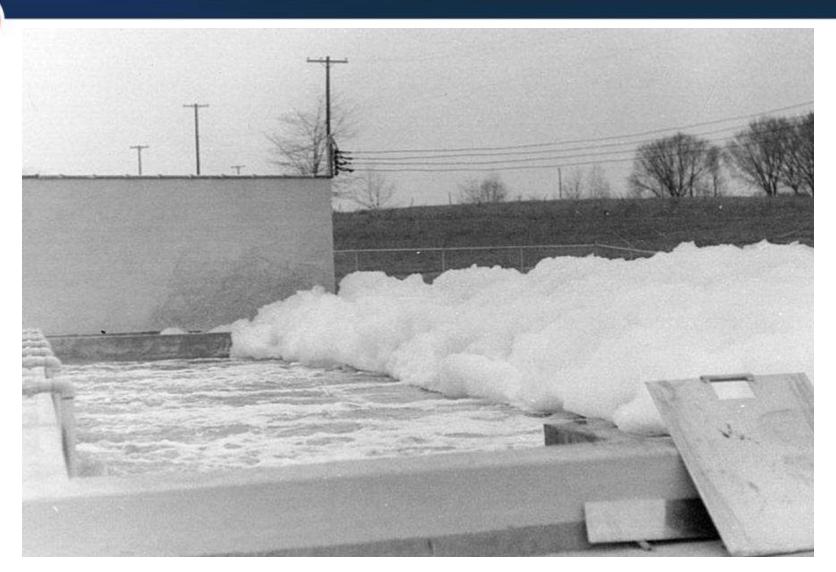
1964 ORIGINAL PLANT CONSTRUCTED

- > Headworks
 - Separate from rest of plant
- > Aeration Basins
 - Outdoor blowers
- > Rectangular Clarifiers
- > Chlorination

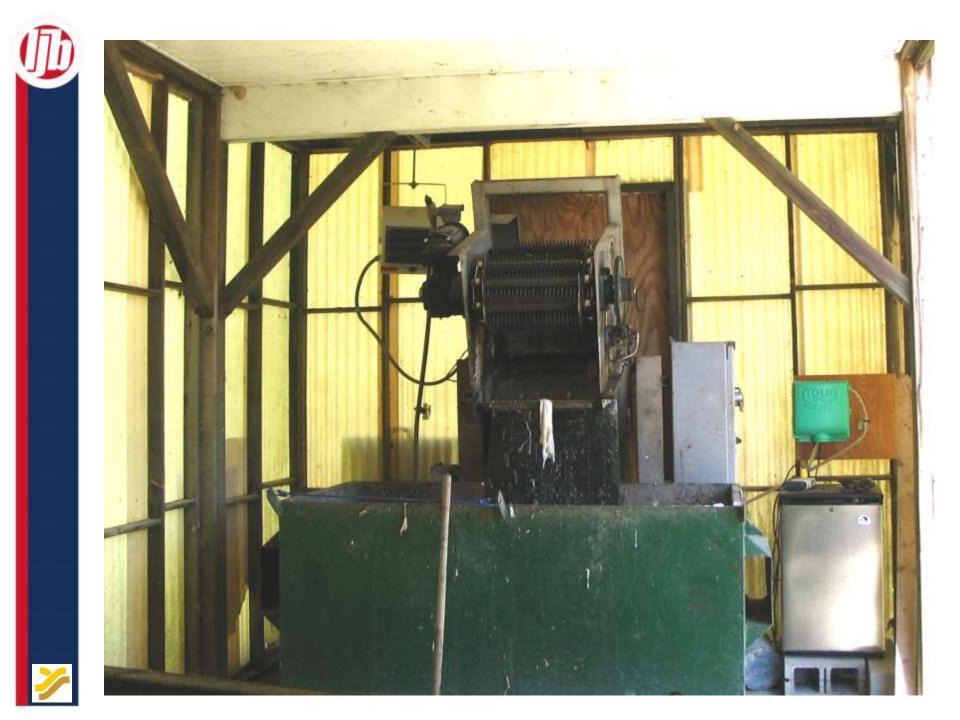
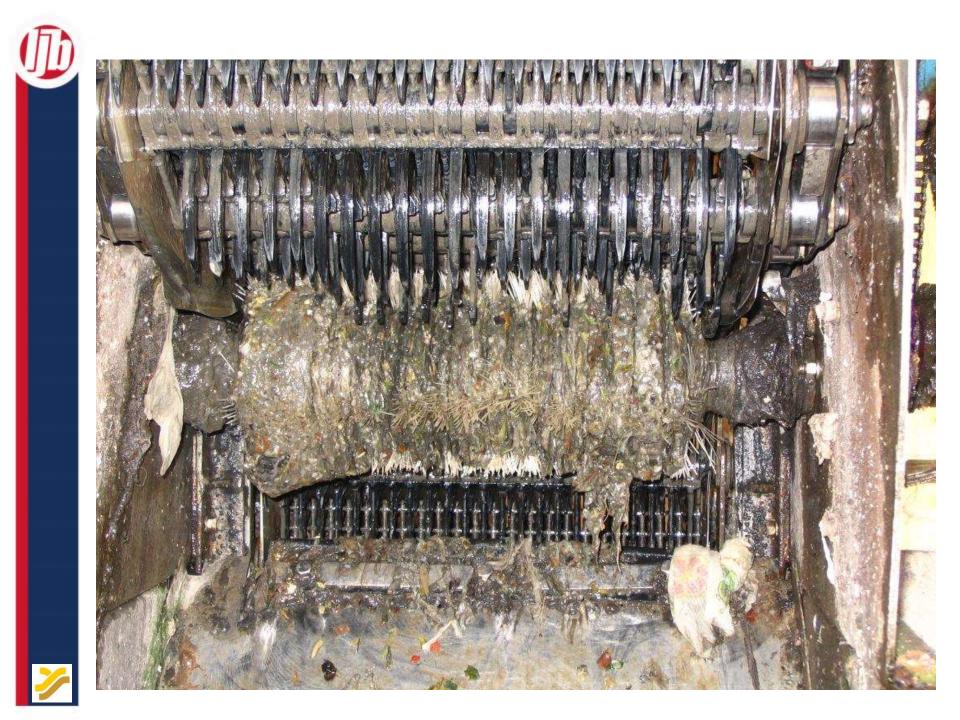
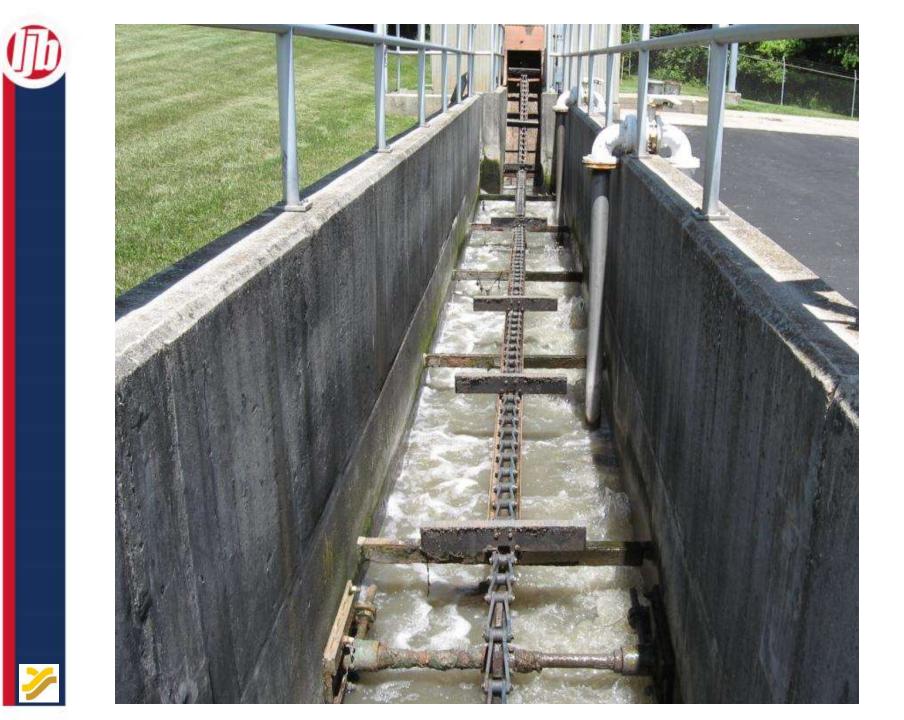
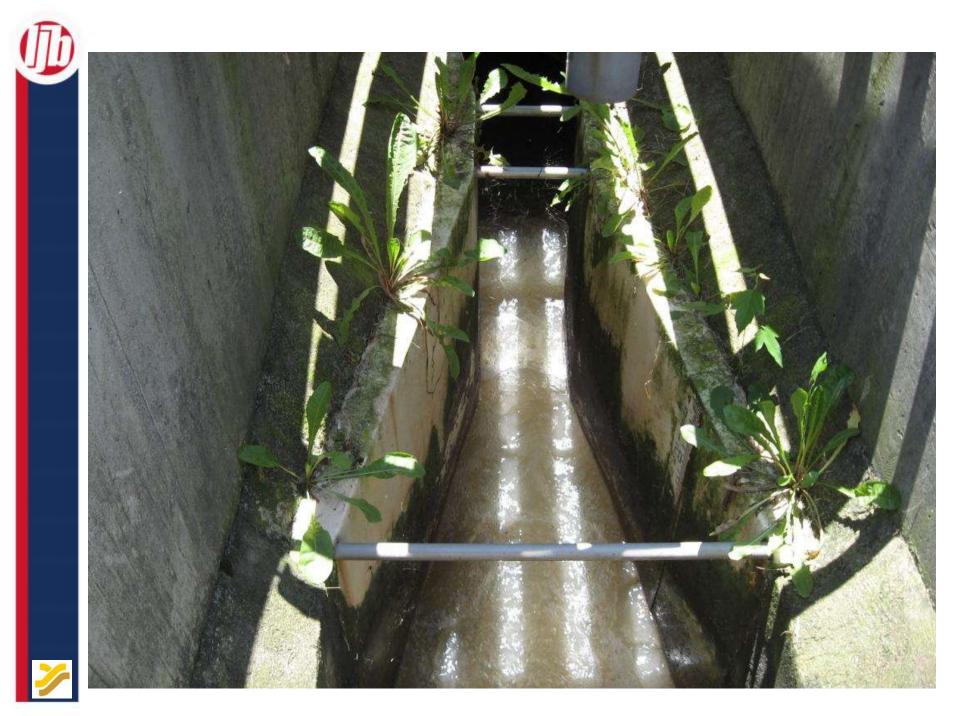
HEADWORKS

- > Screen
 - Old, high maintenance, poor capture
- > Aerated Grit
 - Low efficiency
- > Make-Shift Building
 - Uninsulated
- > Parshall flume
 - Inaccurate due to poor hydraulic design

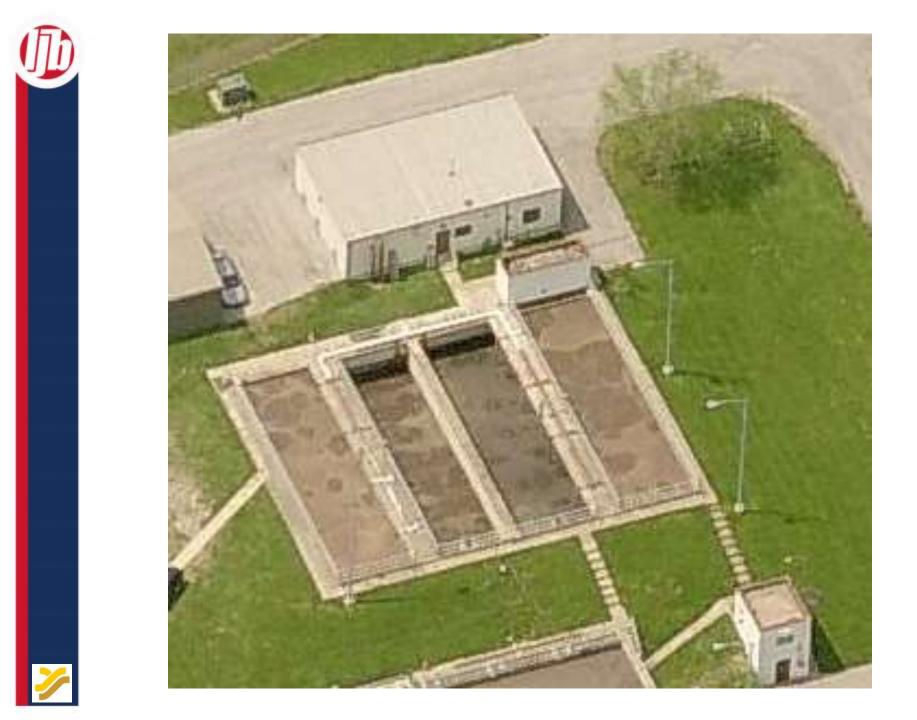
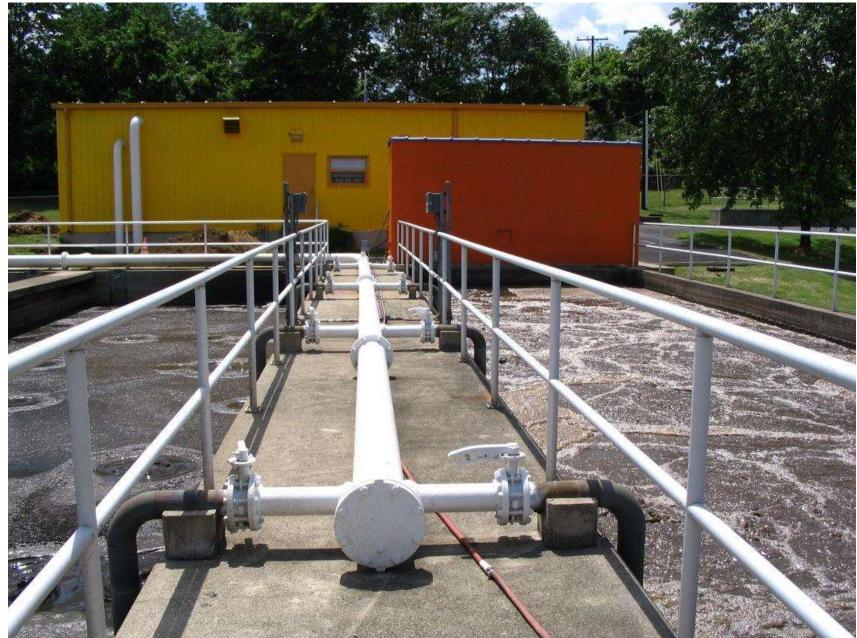
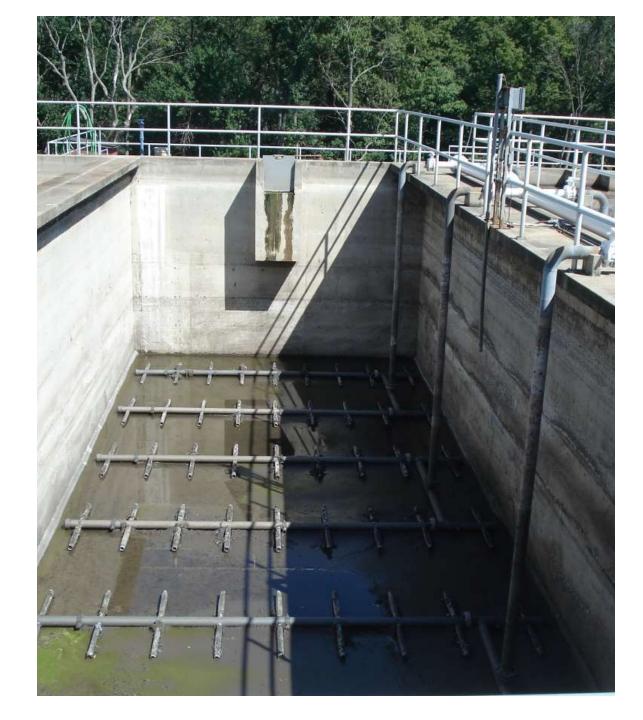
AERATION SYSTEM

- > No Flexibility
 - Four tanks
 - Parallel operation only
- > Only Tanks 1 & 4 On Line
 - Tanks 2 & 3 used for sludge storage

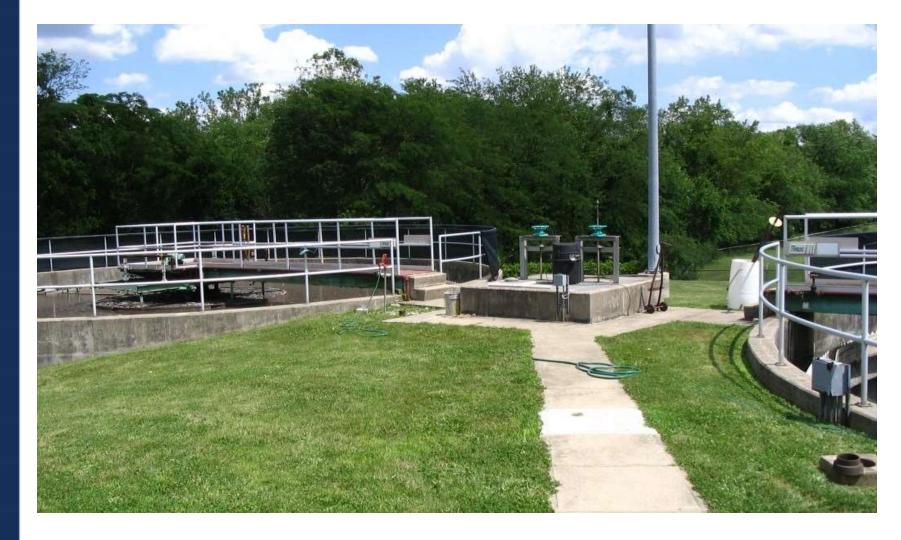
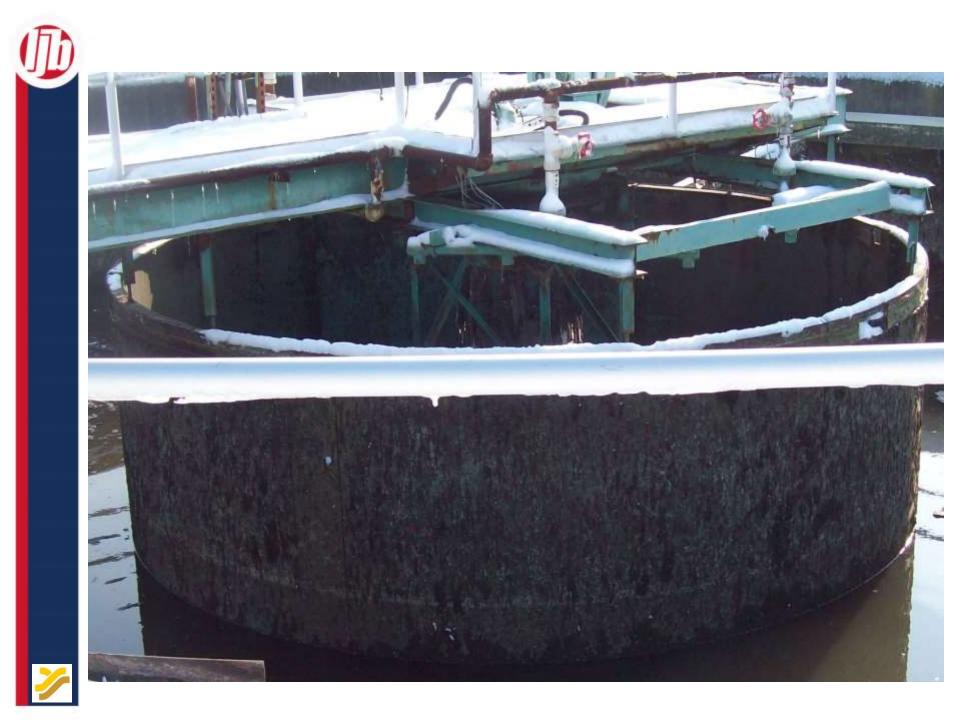
OLARIFIERS

> Single Return Sludge Suction Line

- Unequal flows
- Difficult to have both on line
- > Aging Equipment
 - Rake frame bent
 - Gear box needed rebuilding
- > Debris Problems
 - Center well blockages
 - Cause: Poor screening

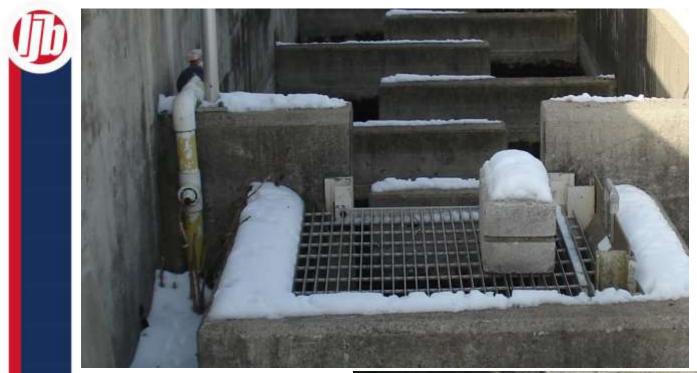
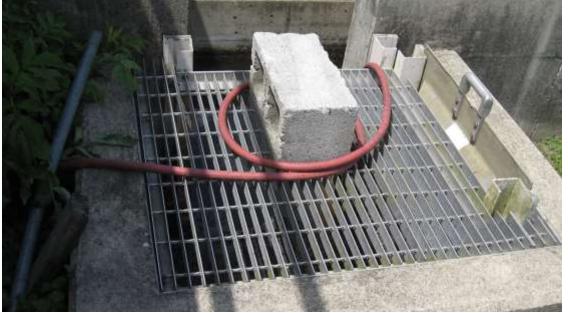
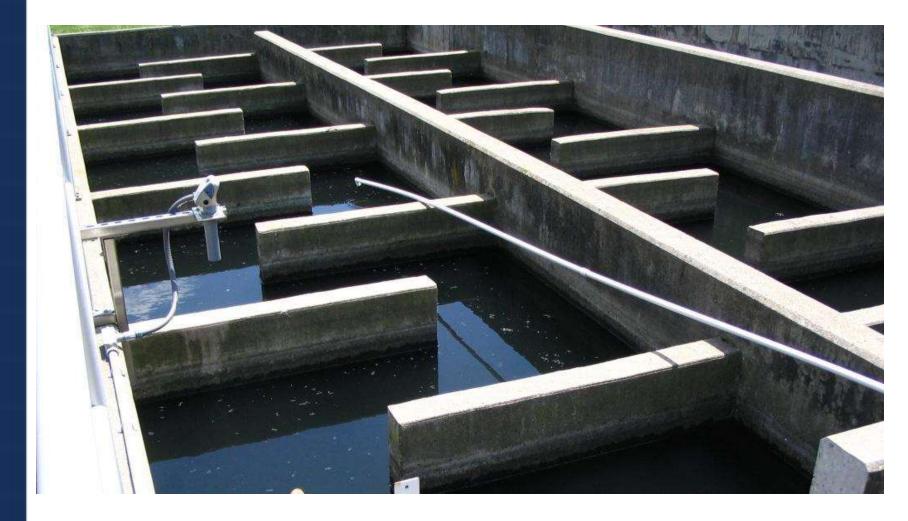
ISINFECTION

- > Leaking Feed Line
- > No Flow Proportioning
- > Improvised Dechlorination

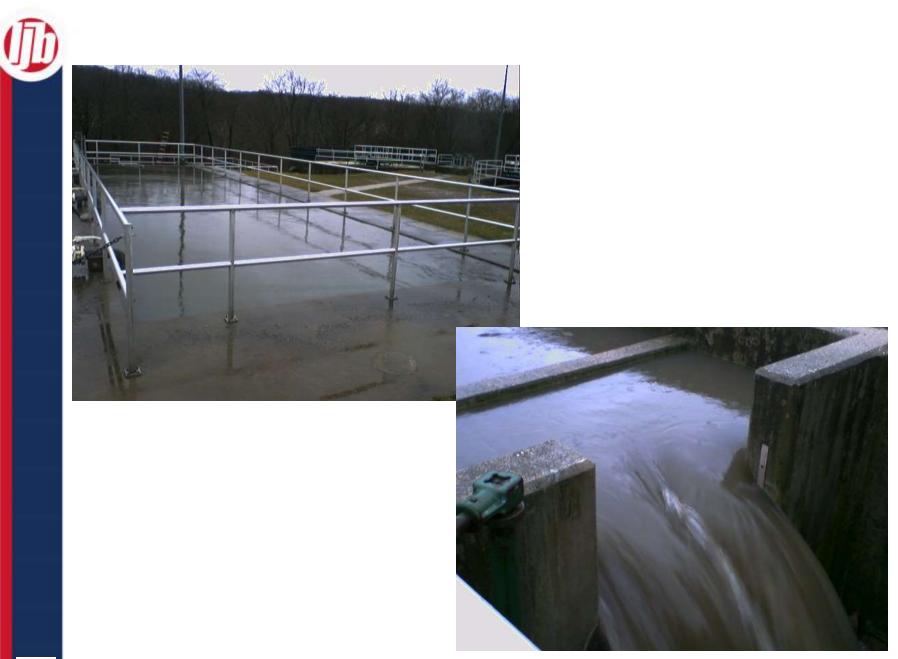
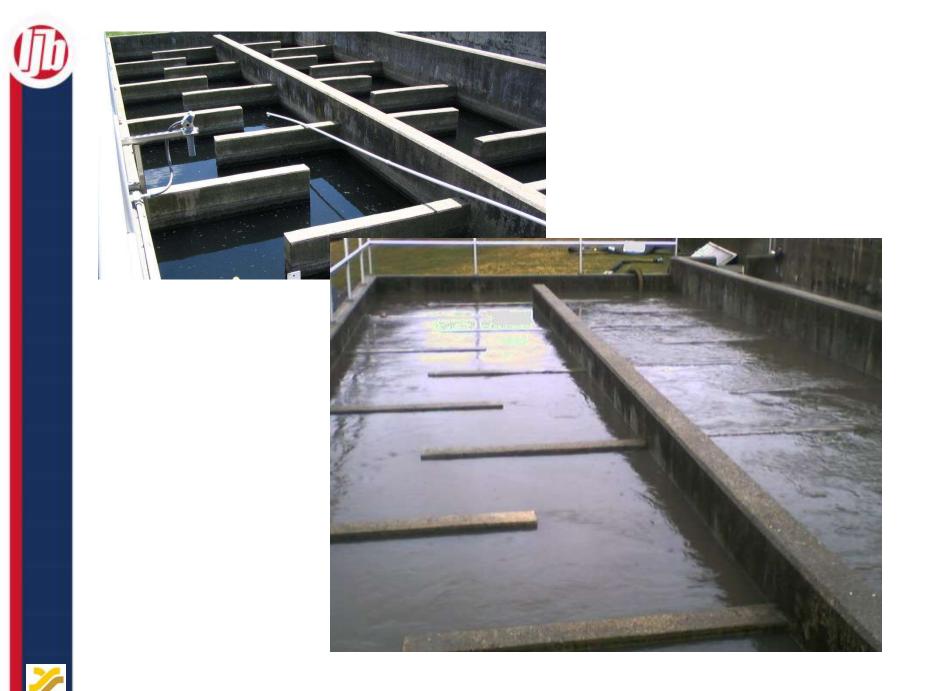
IIGH FLOW PROBLEMS

- > Permit Violations
 - MLSS Washout
 - Lingering High Ammonia
- > Strategies for Coping
 - One Clarifier used for Storm Storage
 - Aeration Tank for Holding Solids
 - Internal Bypass Used

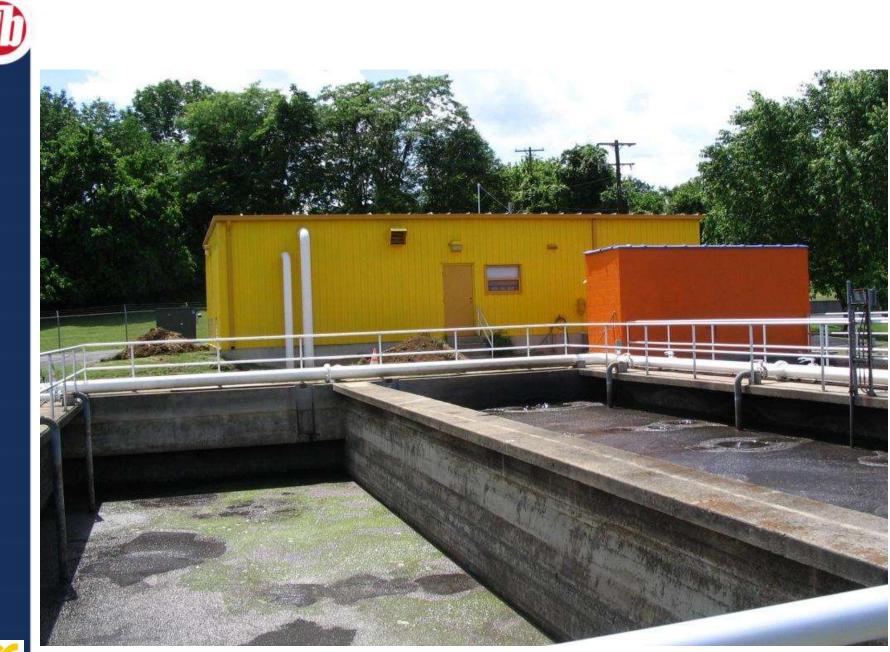
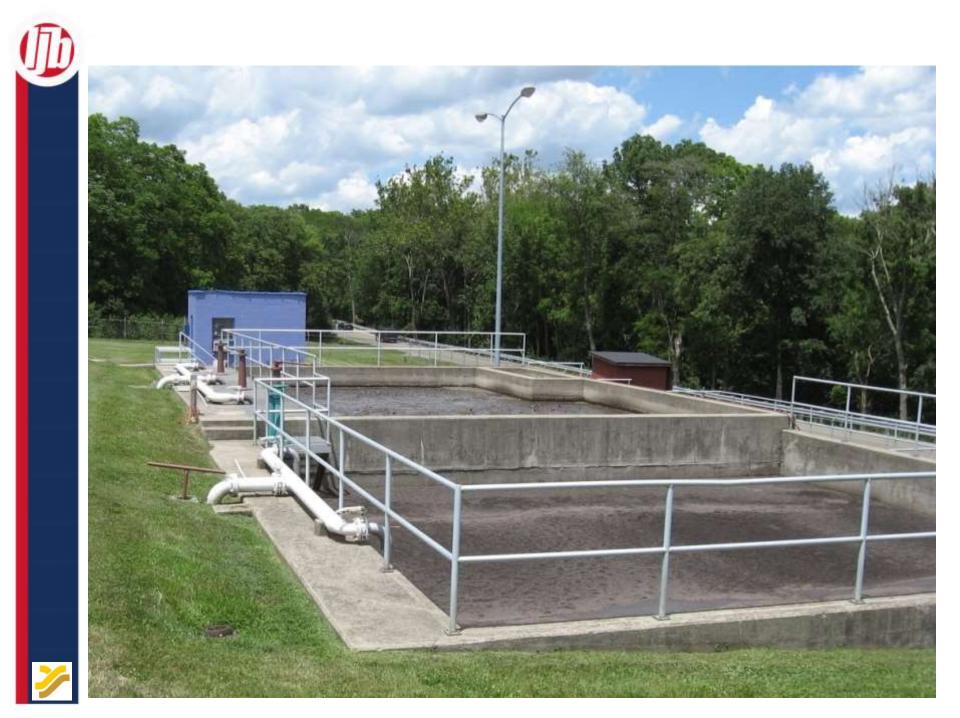
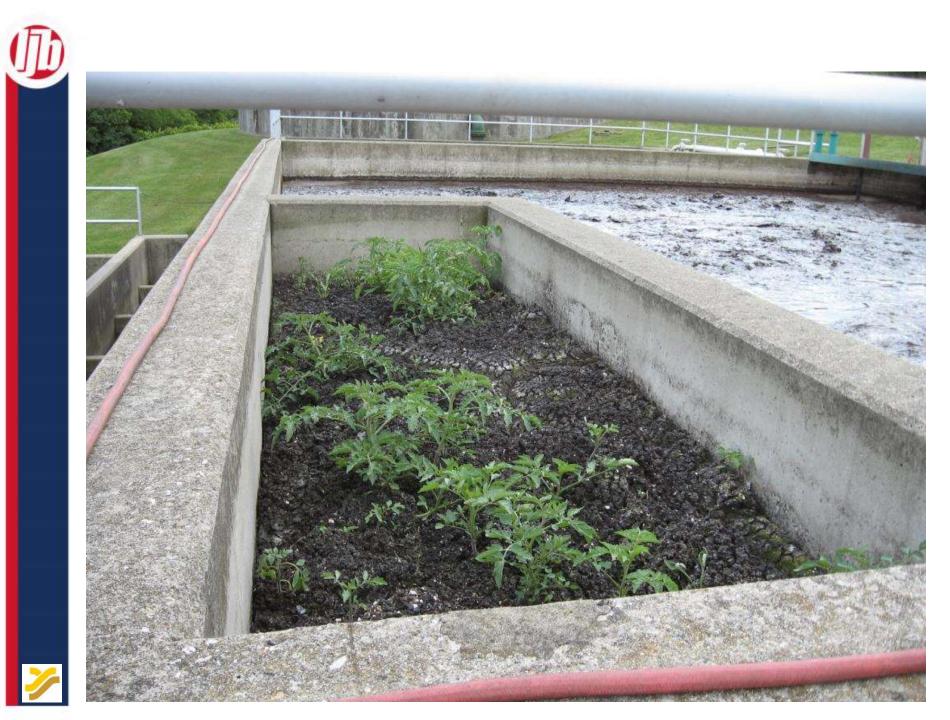
SLUDGE MANAGEMENT

- > Insufficient Liquid Storage
- > Disposal by Liquid Hauling Before 2006
- > 2006 Synagro Contract for Dewatering and Land Application
- > No On-Site Storage for Dewatered Sludge

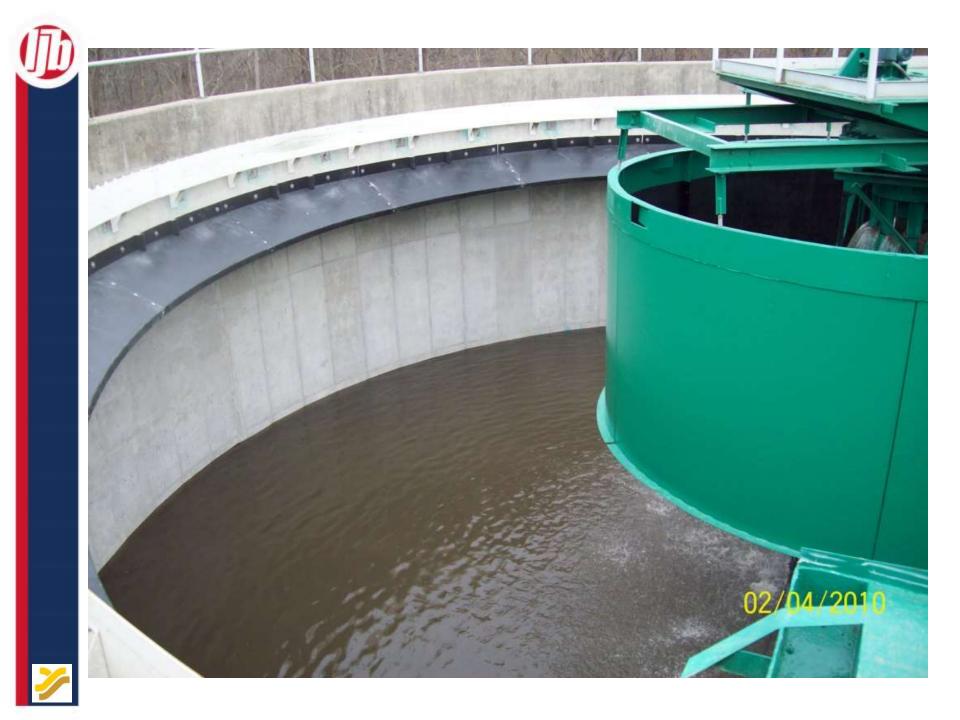
IIGH INFILTRATION & INFLOW

- > Solution Components:
 - Provided separate return sludge lines for each clarifier
 - Allowed regular use of both clarifiers
 - Undertaken as early project
 - Increased clarifier efficiency
 - Add current density baffles

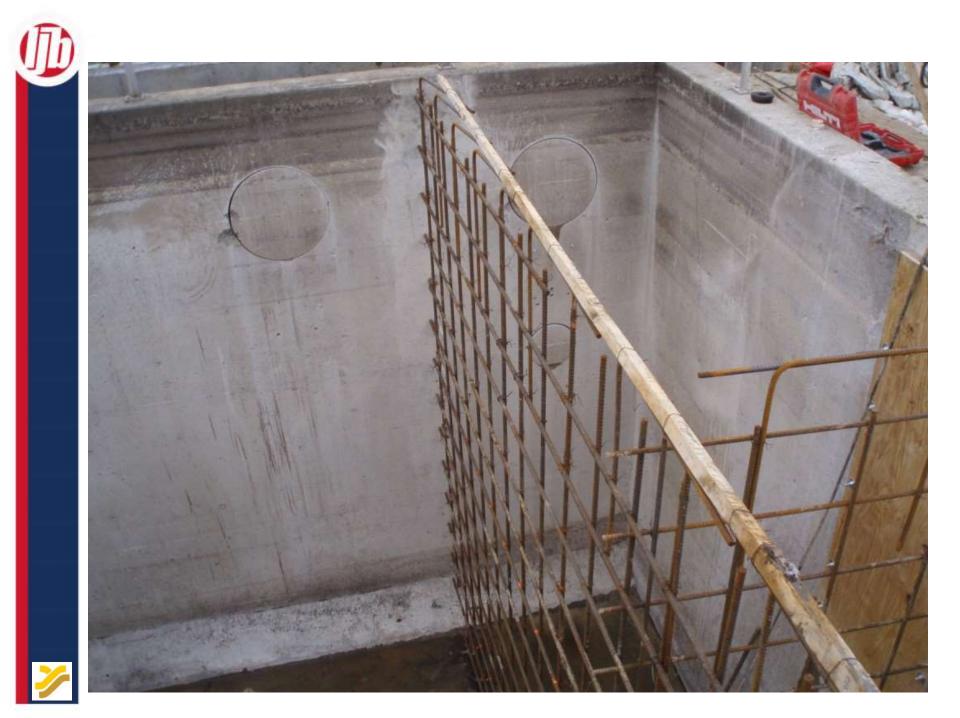
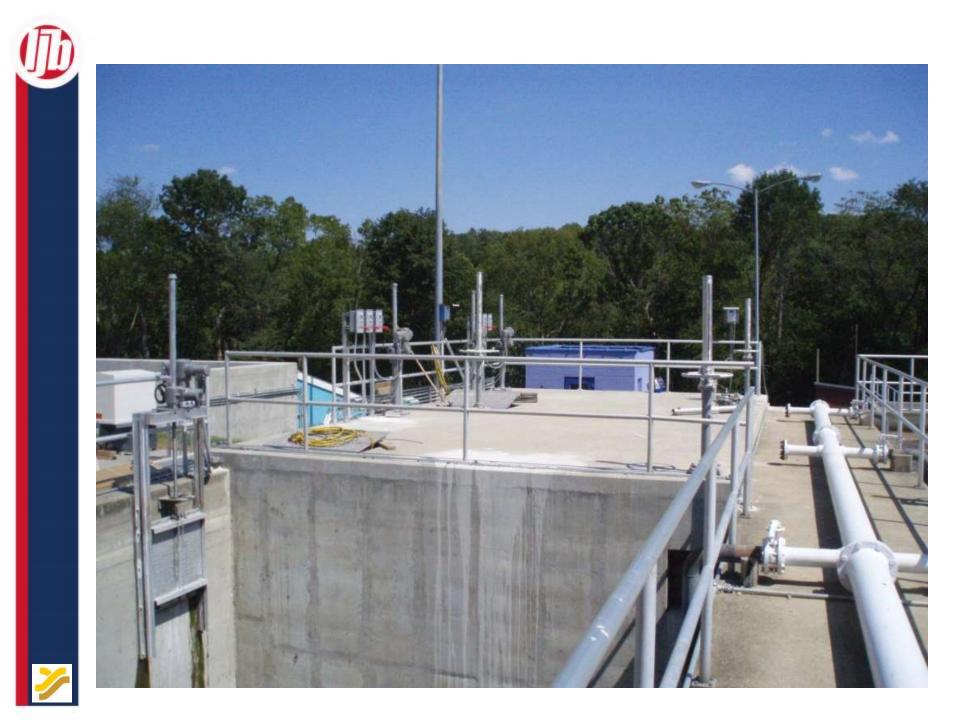
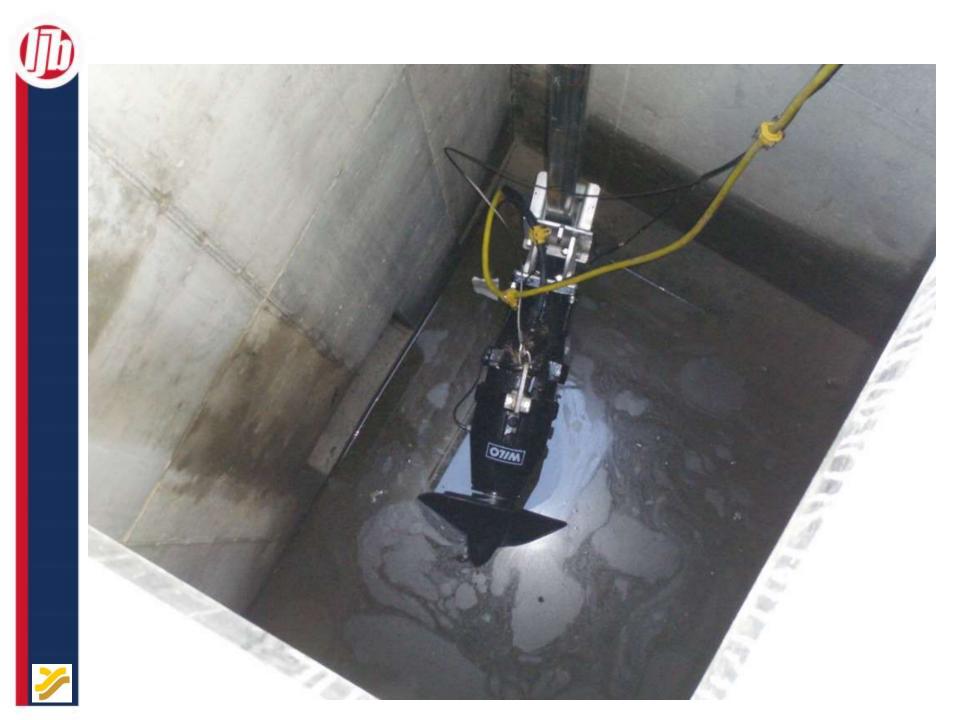
MEETING PHOSPHORUS LIMITS

- > Solution Components:
 - Biological nutrient removal
 - Added anaerobic selector chambers
 - » Three chambers of increasing detention time
 - » Covered and Mixed
 - Enhanced denitrification
 - » Mixed anoxic tank
 - » Recirculation propeller pump

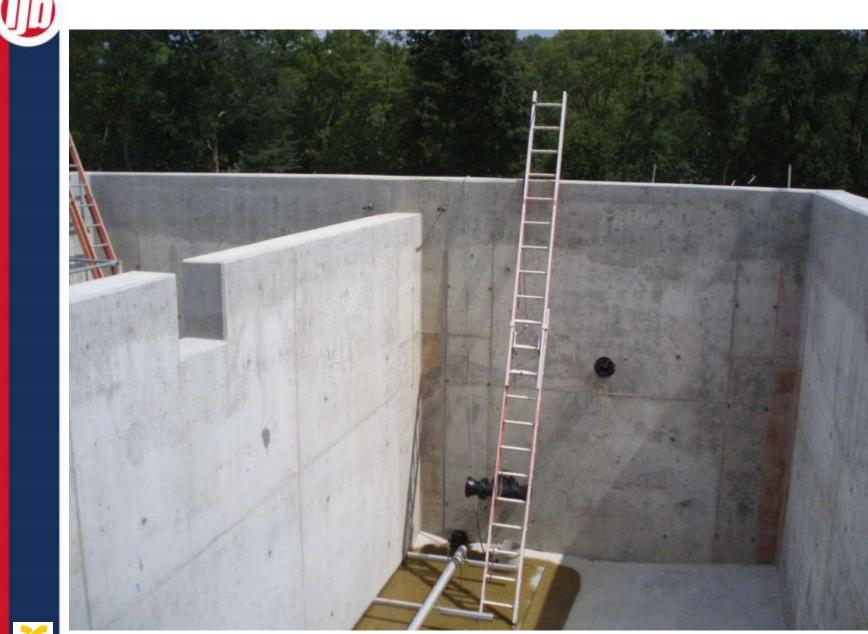
MEETING PHOSPHORUS LIMITS

- > Solution Components:
 - Biological nutrient removal
 - Sidestream phosphorus treatment system
 - Chemical treatment of high-P waste streams
 - » Digester decant
 - » Dewatering filtrate
 - » Sludge pad runoff

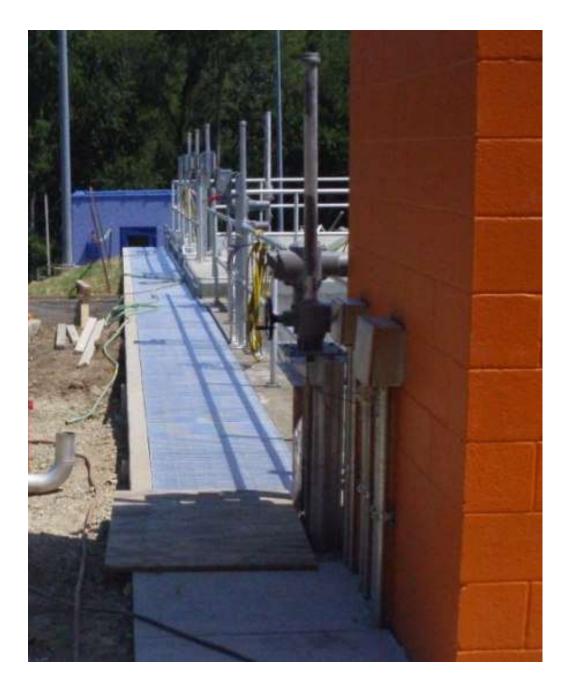
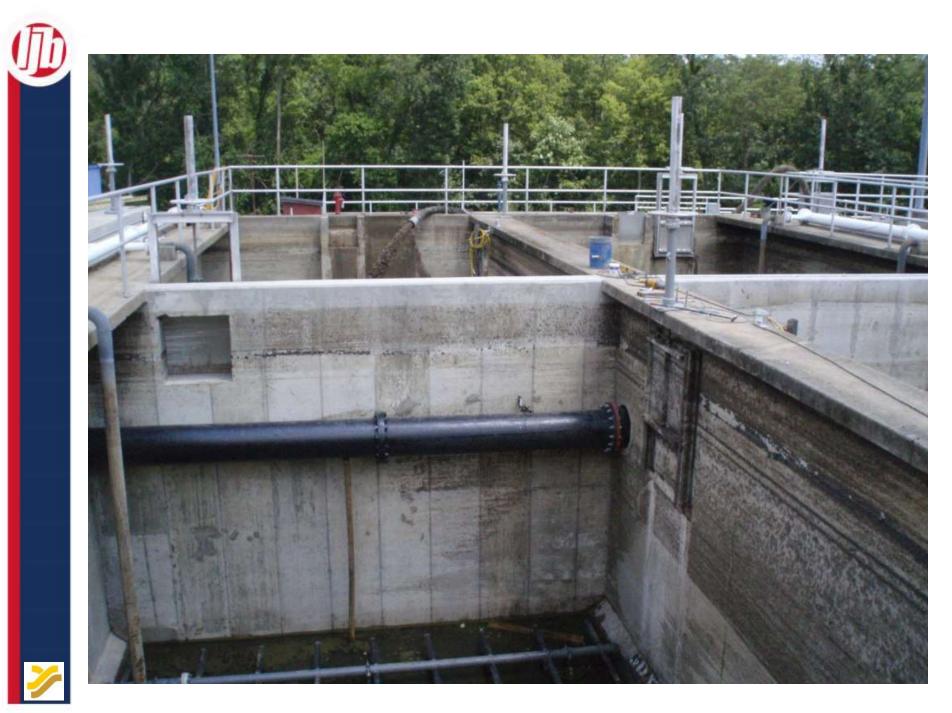
INCREASING OPERATIONAL FLEXIBILITY

- > Solution Components:
 - Multiple Aeration Compartments
 - Allows combined series and parallel flow
 - Allows tanks to be taken off line
 - Multiple Points of Wastewater Entry
 - Allows for "Storm Mode" to hold mixed liquor
 - Reduces solids loading to clarifiers at high flows

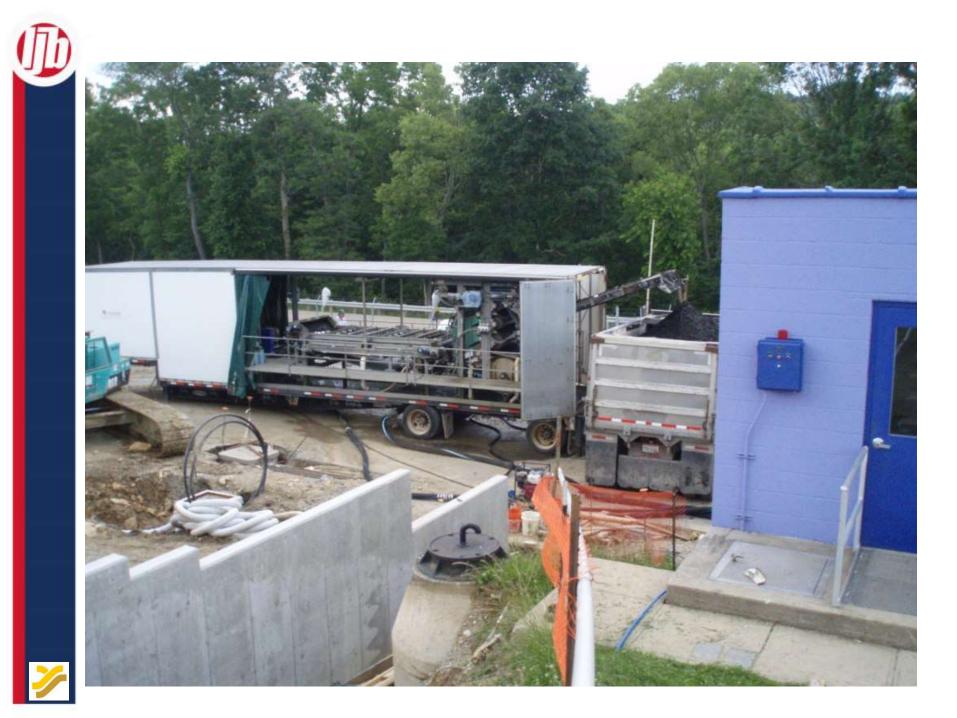
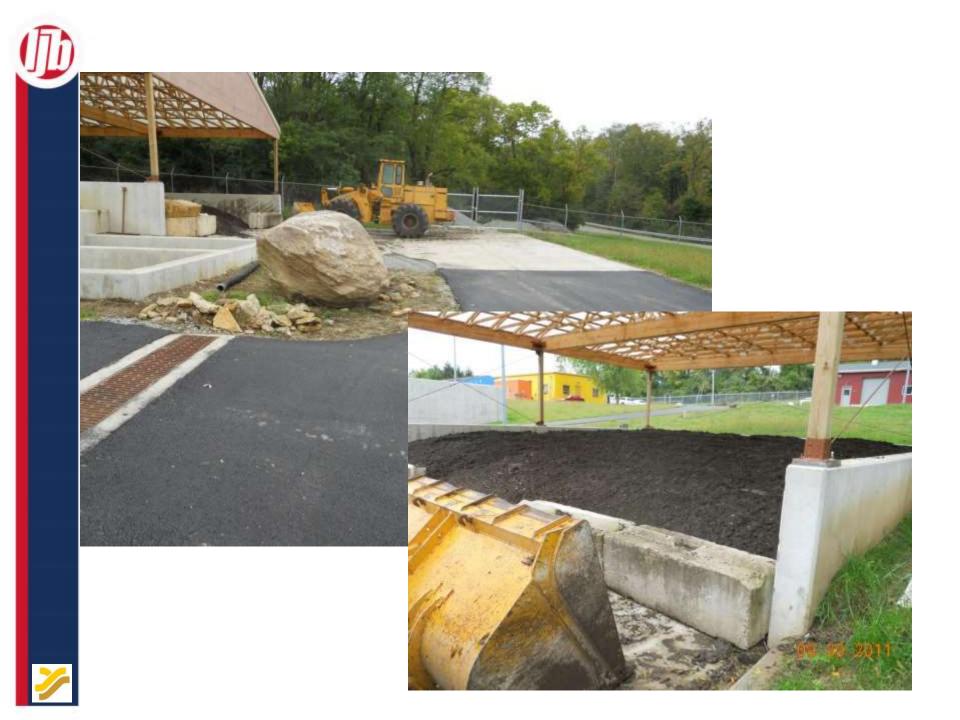
IMPROVED SLUDGE MANAGEMENT

- > Solution Components:
 - Covered Storage for Dewatered Sludge
 - Allows dewatering when needed, not when fields can take sludge
 - Additional stabilization time

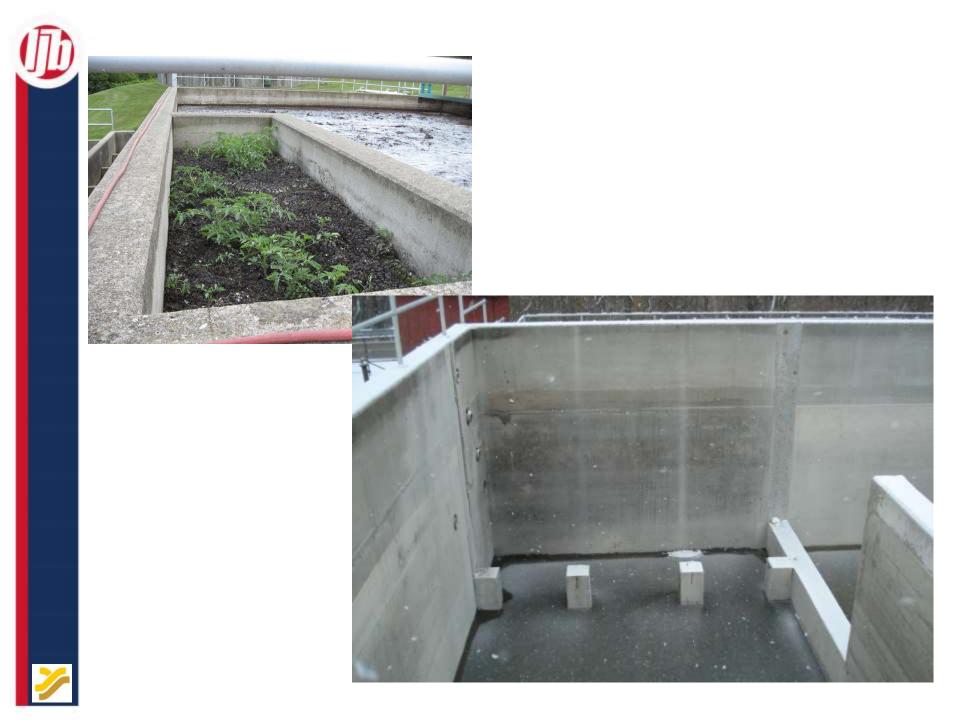
IMPROVING SLUDGE MANAGEMENT

- > Solution Components:
 - Covered Storage for Dewatered Sludge
 - Improved Decanting Ability
 - Removed divider wall
 - Improved thickening
 - Decant to phosphorus treatment system

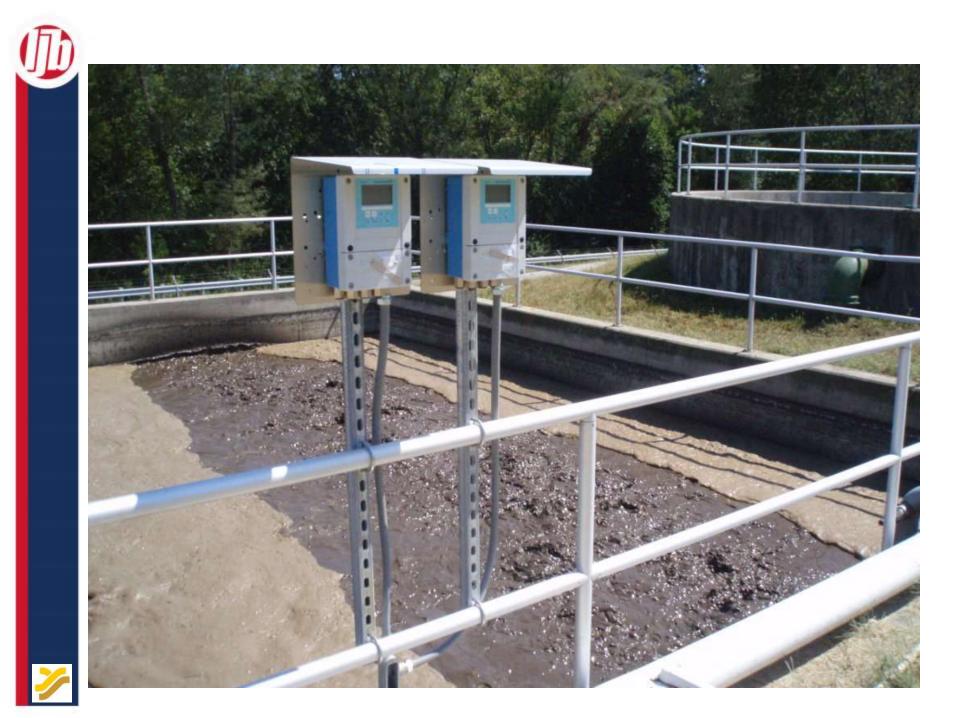
IMPROVING SLUDGE MANAGEMENT

- > Solution Components:
 - Covered Storage for Dewatered Sludge
 - Improved Decanting Ability
 - Capacity for Sequencing Facultative Digestion
 - ORP and pH probes added to each tank
 - Sequencing by controlling aeration

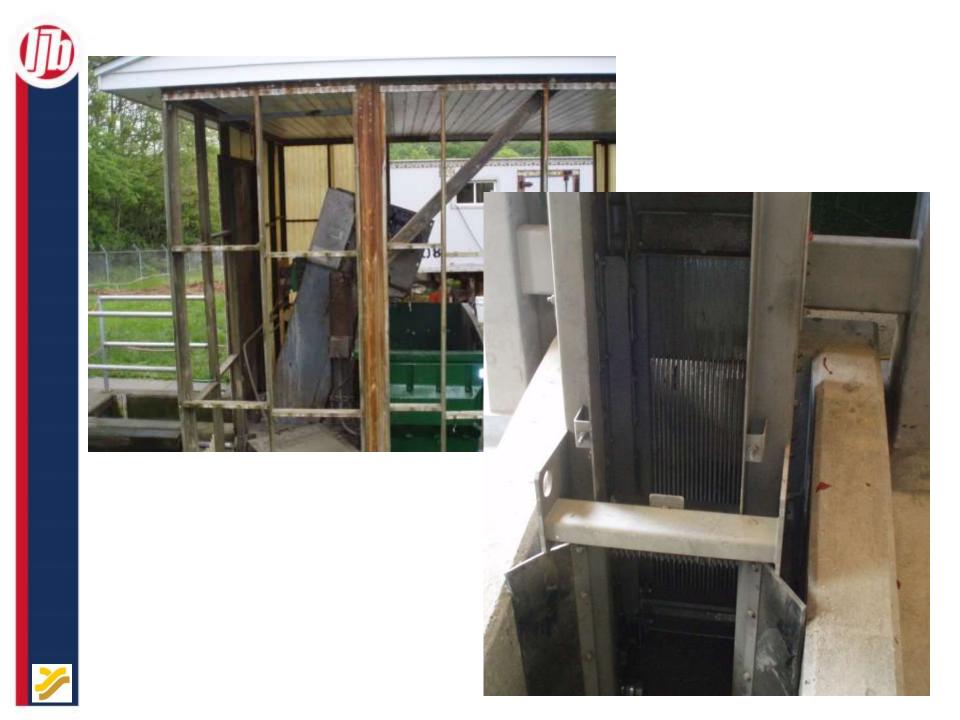
> Replaced Influent Screen

- Old screen "died" in June 2010
- Used manual bar screen as interim measure
- New screen on line in August 2010
- 1/4" bar spacing
- Front cleaning rakes no carry through
- Tilts for maintenance

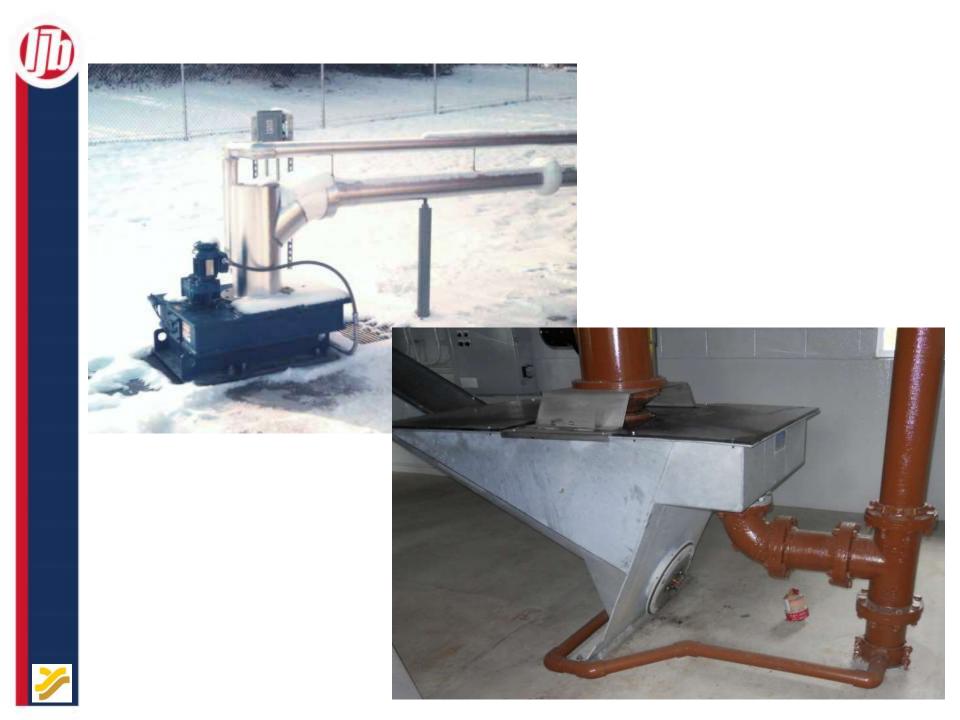
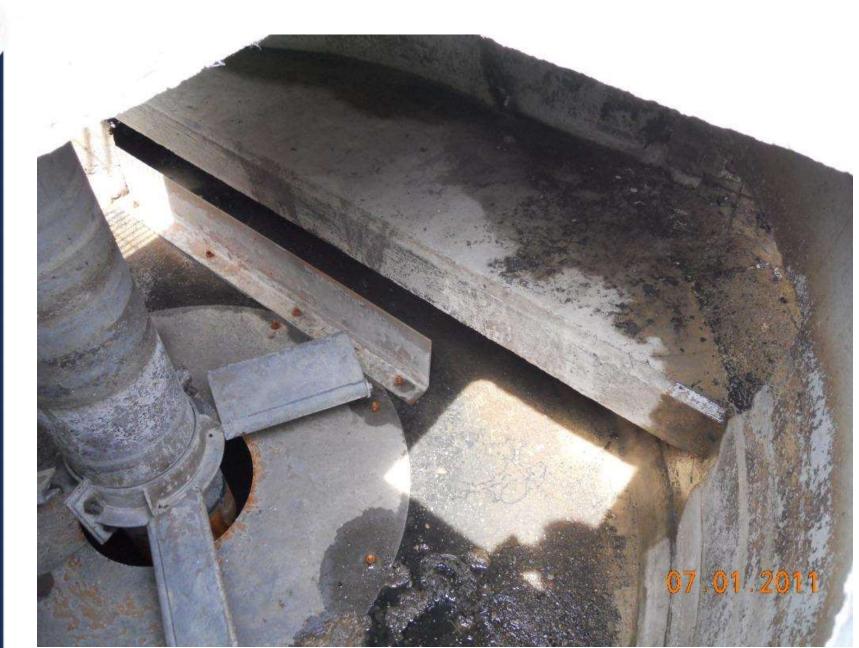
- > Replaced Influent Screen
- > Replaced Aerated Grit System
 - Vortex grit system
 - Grit pump
 - Grit washing

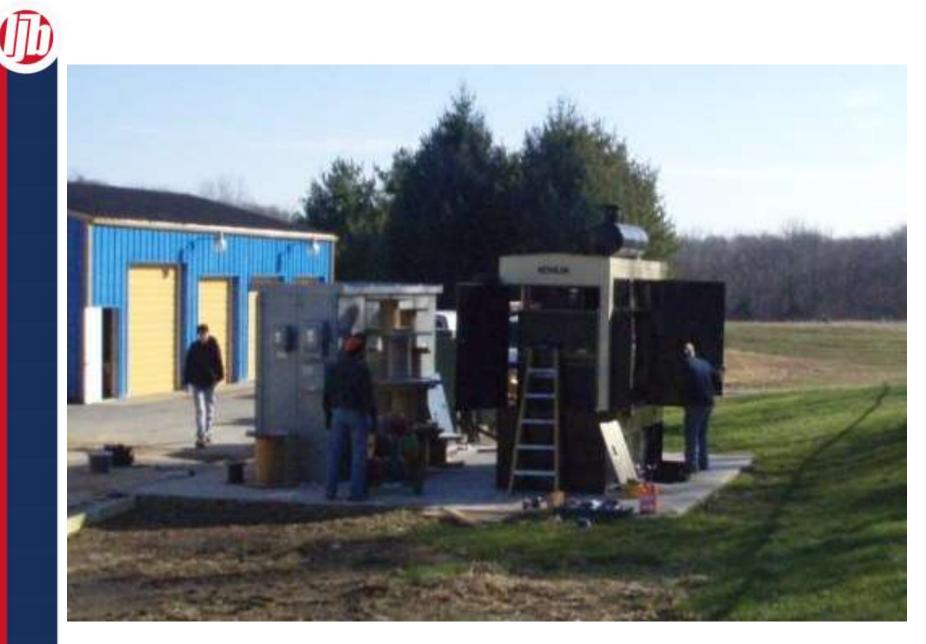
- > Replaced Influent Screen
- > Replaced Aerated Grit System
- > Replaced Parshall Flume
- > Non-Potable Water System
- > Emergency Generator and Automatic Transfer Switch

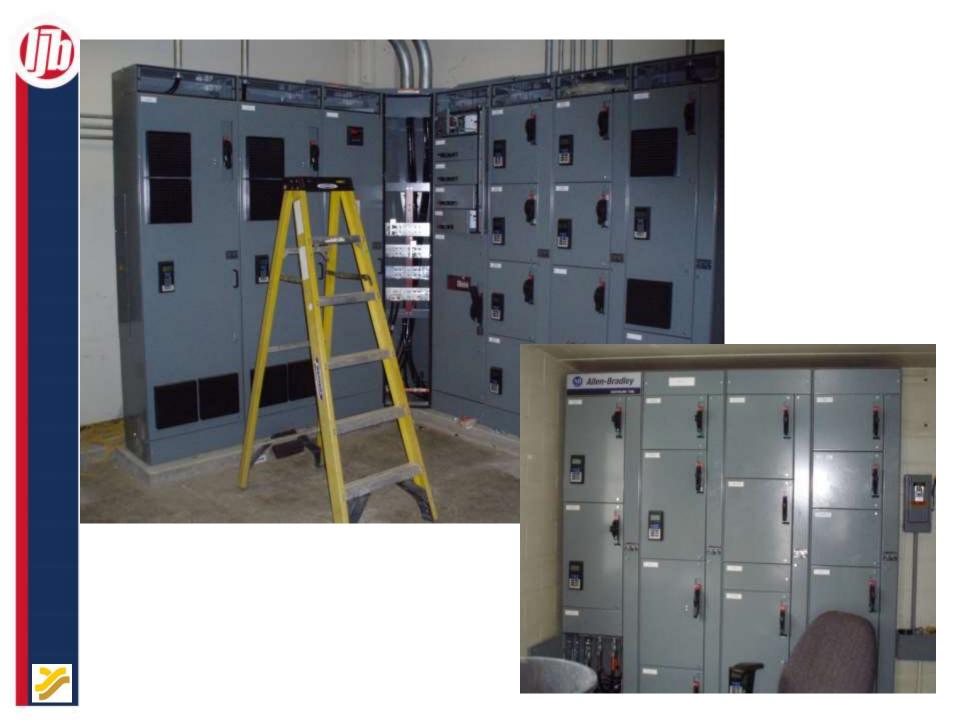
- > Replaced Influent Screen
- > Replaced Aerated Grit System
- > Replaced Parshall Flume
- > Non-Potable Water System
- > Emergency Generator and Automatic Transfer Switch
- > Electrical Systems and Switch Gear

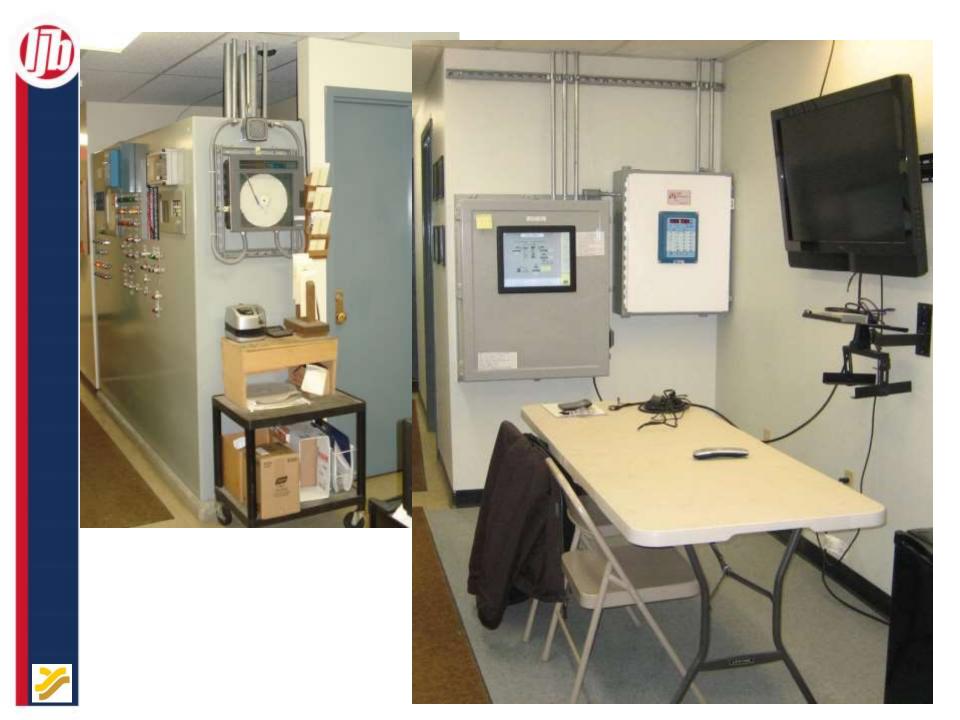
- > Replaced Influent Screen
- > Replaced Aerated Grit System
- > Replaced Parshall Flume
- > Non-Potable Water System
- > Emergency Generator and Automatic Transfer Switch
- > Electrical Systems and Switch Gear
- > Operational Controls and SCADA
